# Down Under

*Choice Construction uses 28, 120-foot lifts to access damaged sections of Hoan Bridge*

■ *By Barry Gantenbein, editor, Western Builder*

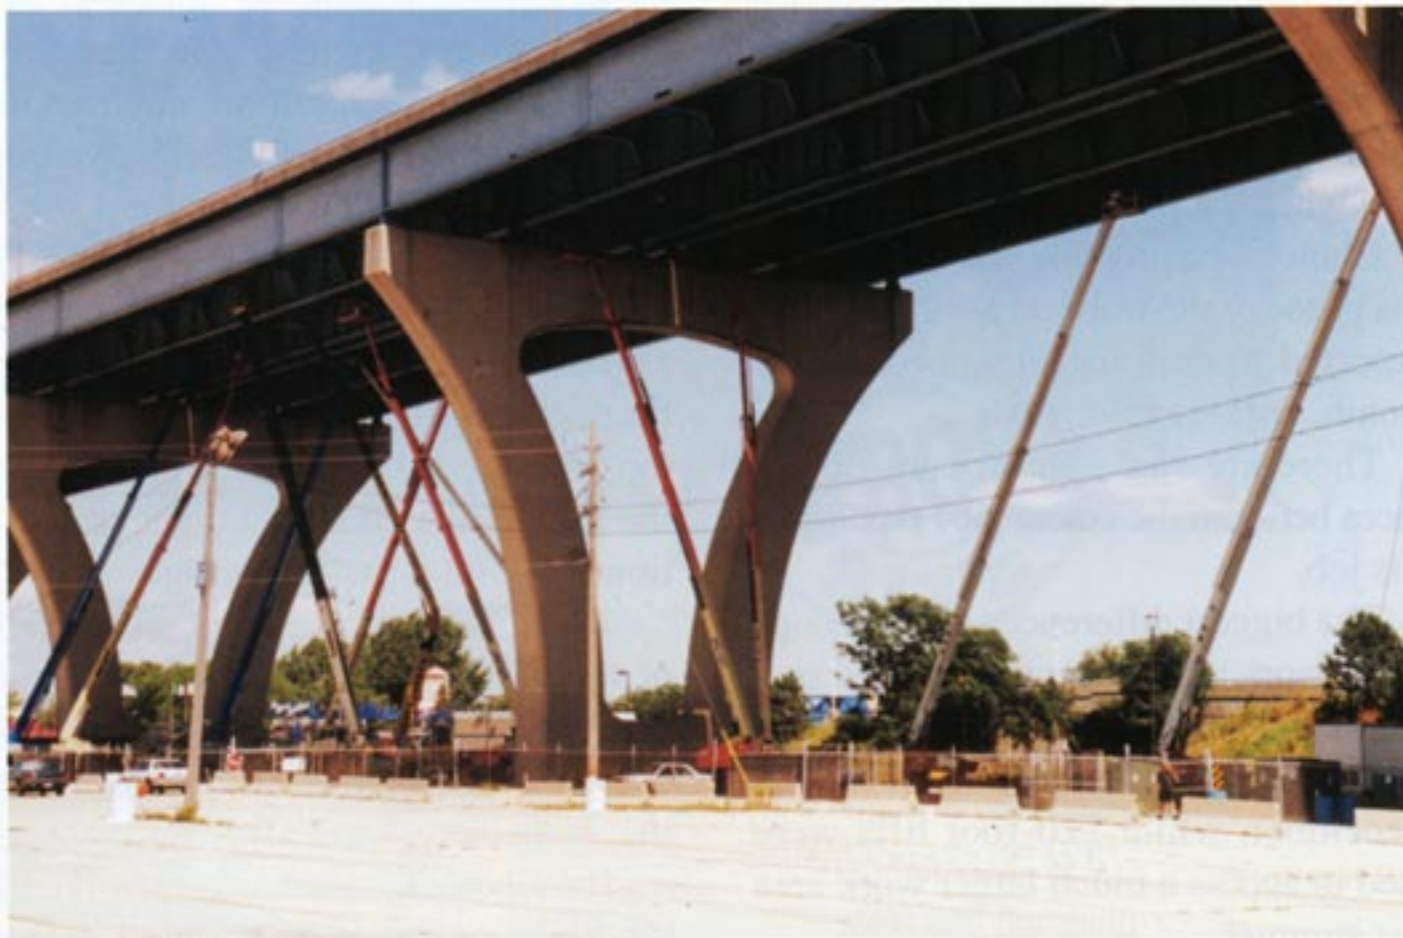
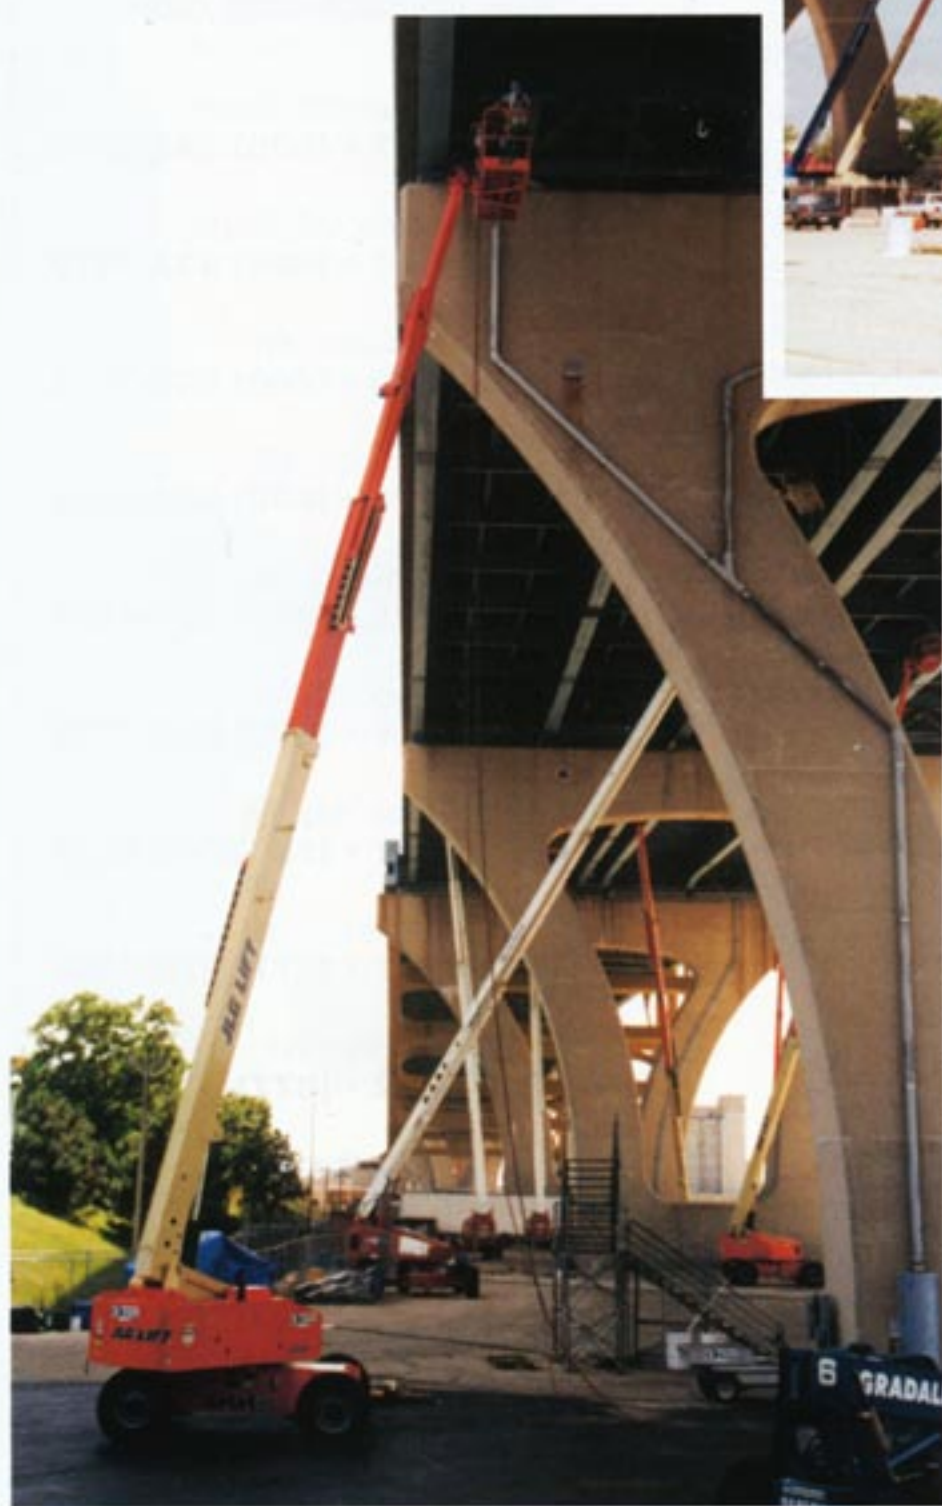
The Choice Construction crew is using 120-foot lifts to access damaged sections of the bridge, which are being removed by mechanical means.

Right: A JLG lift on the job, one of 28 lifts rented from United Rentals.

Bottom right: A photo of some of the 28, 120-foot lifts Choice Construction rented to remove lower lateral bracing at the Hoan Bridge in Milwaukee.

The Choice Construction crew on the job, which peaked at 25, is using 120-foot lifts to gain access to damaged sections of the bridge, which are being removed by mechanical means. Pieces are hoisted down by crane, with the largest piece removed weighing in at 1,600 pounds.

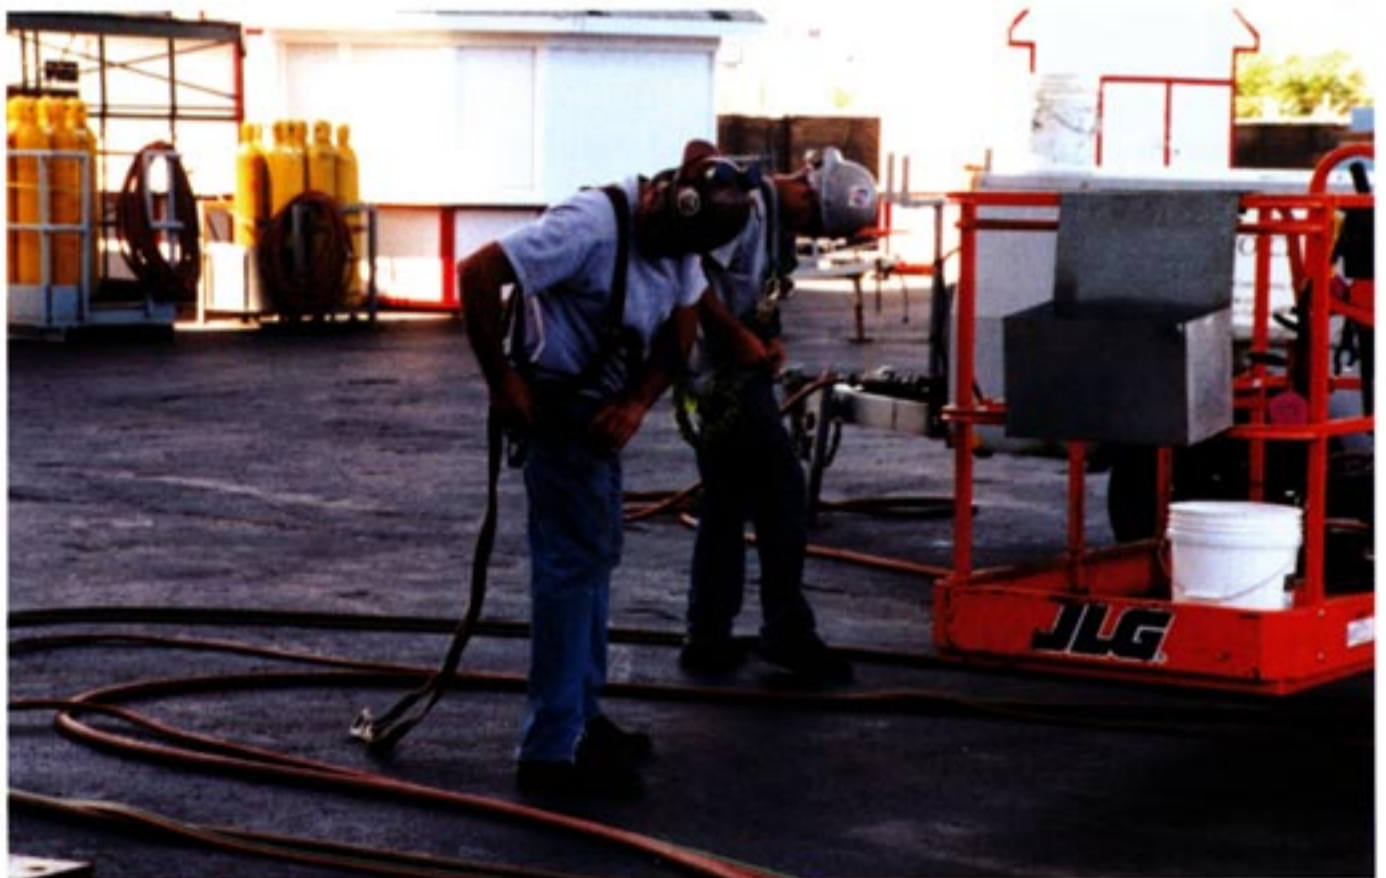
Choice Construction employees put on safety harnesses before getting on a JLG lift to do repair work at the Hoan Bridge. The bridge received national attention in December when a 200-foot section buckled, and was demolished with the use of explosives.
